Manhole Inspection Summary

Manhole # S21WW1054MH

Insp Date: **5/2/07 1:27 PM**

Location Address: **5109 FALLS ROAD TERR**

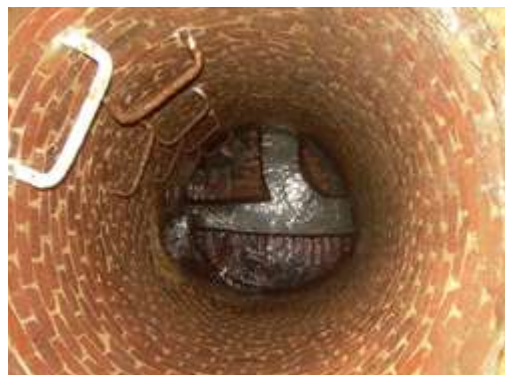
Top View

Corroded steps. Bench debris.

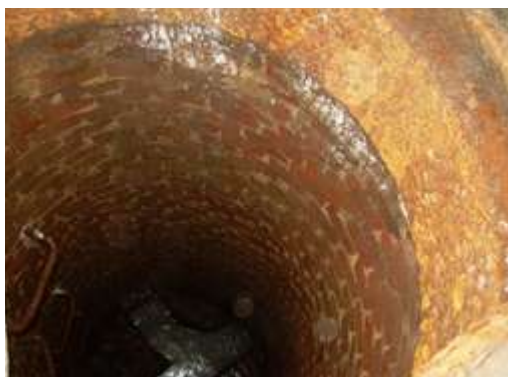
Defect

Infiltration: ☐ None ☒ **Joint** ☐ Cracks ☐ Mortar ☐ Roots ☒ **Wall**

Infiltration: ☐ None ☐ Joint ☐ Cracks ☐ Mortar ☐ Roots ☒ **Wall**

Corbel and Barrel infiltration.

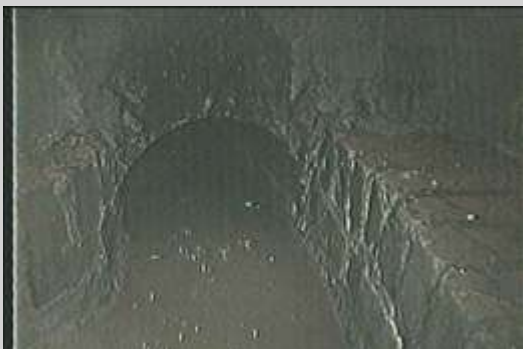
10 in. Circular Gravity Sewer Pipe In @ 3 O'Clock

Channel deterioration.

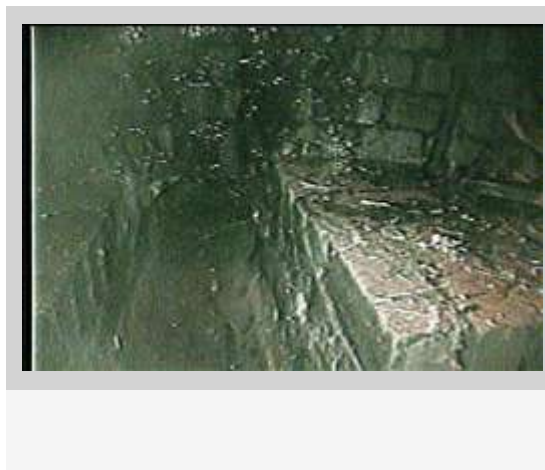
Drop In @ 9 O'Clock

Drop Condition: **Partly Clogged**
